# Manhole Inspection Summary

Manhole # **S15GG\_022MH**

Insp Date: **9/19/07 3:25 PM**

**Location** Address: **2731 BAKER ST** Cross Street: **ASHBURTON ST**

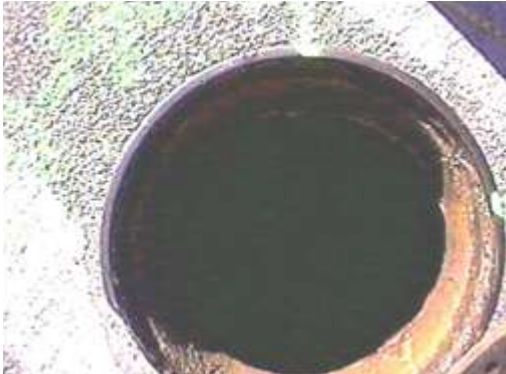
Defect 3

**Frame** Offset: **2** (in.) Condition: ☒ Sound ☐ Cracked ☐ Leaks

offset frame

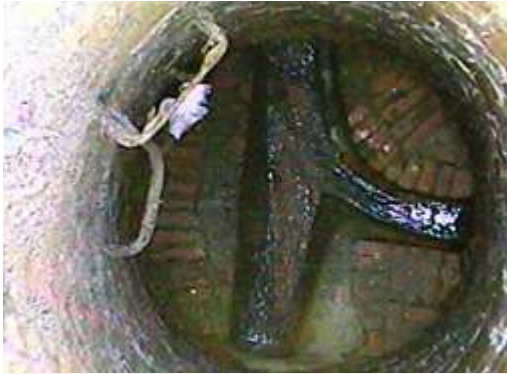
Defect 2

**Surcharge** ☒ **Evidence Of Surcharge** Depth: **3.5** (ft.) ☐ Active Surcharge Present

evidence surcharge

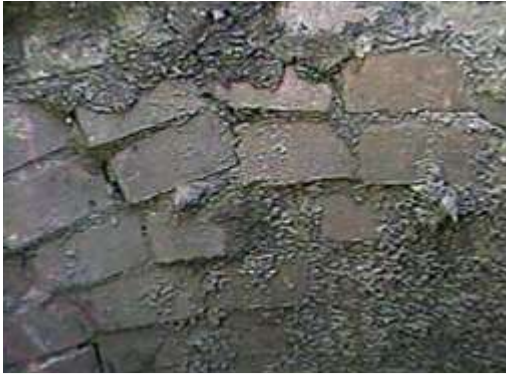
Defect 1

**Steps** Count: **4** Missing: **1** ☒ **Corroded**

CORRODED MISSING RUNG

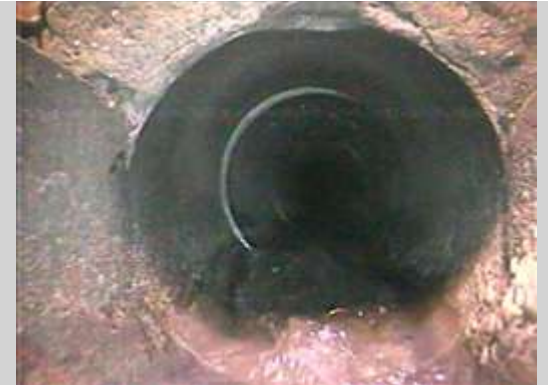
12 O'Clock Outflow

12 in. Circular Gravity Sewer  
Pipe Out @ 12 O'Clock

Pipe Height: (in.) Direct  
Pipe Material: **Clay** ☐ Pipe Lined  
Invert Depth: **7.69** (ft.) Flow Characteristics: **Fast**  
Deposits: ☒ None ☐ Mud ☐ Sludge ☐ Debris ☐ Grease  
Silt Depth: (in.) Deposits Extent:  
Infiltration: **None** Pipe Seal Cond: **Sound**

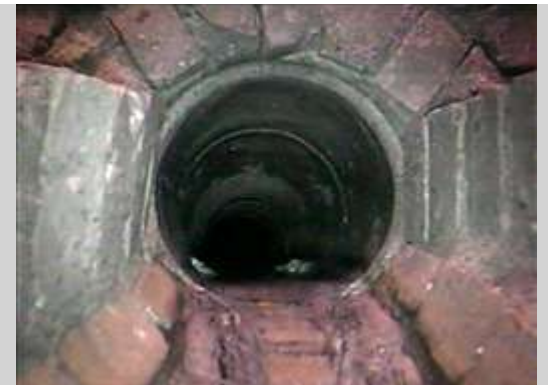
3 O'Clock Inflow

8 in. Circular Gravity Sewer  
Pipe In @ 3 O'Clock

Pipe Height: (in.) Direct  
Pipe Material: **Clay** ☐ Pipe Lined  
Invert Depth: **7.39** (ft.) Flow Characteristics: **Slow**  
Deposits: ☒ None ☐ Mud ☐ Sludge ☐ Debris ☐ Grease  
Silt Depth: (in.) Deposits Extent:  
Infiltration: **None** Pipe Seal Cond: **Sound**

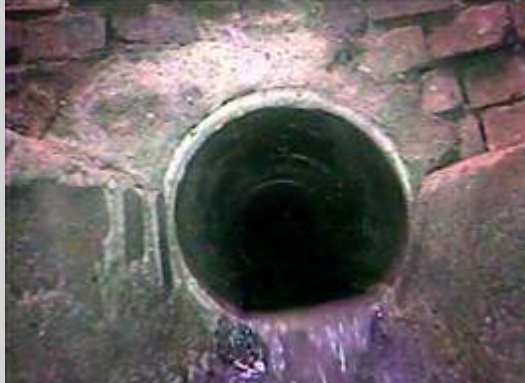
6 O'Clock Inflow

10 in. Circular Gravity Sewer  
Pipe In @ 6 O'Clock

Invert Depth: **7.46** (ft.) Flow Characteristics: **Fast**

Infiltration: **None** Pipe Seal Cond: **Sound**
